Manhole Inspection Summary

Manhole # S33O1_023MH

Inspection ☐ Is Incomplete Rating: **3) Fair**

Location Address: **400 Reedbird Ave** Cross Street: **Seagull-Reedbird**

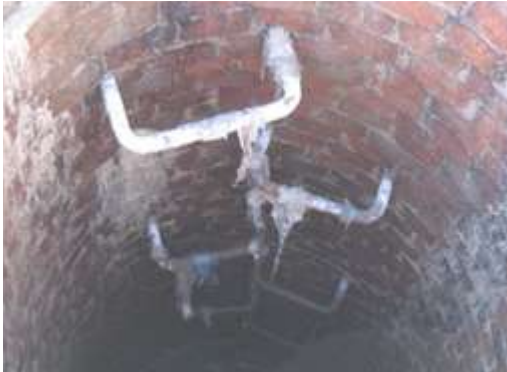
Steps Count: **8** Missing: **0** ☐ Corroded

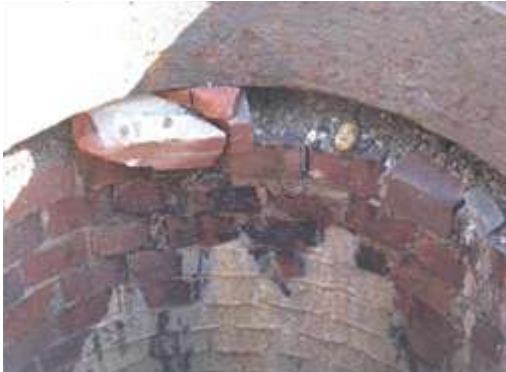
Defect 1

Chimney / Frame Adjustment ☒ Exists Material: **Brick** ☐ Parged Height: **2** (in.)
Condition: ☐ Sound ☐ Cracked ☐ Root Intrusion ☒ **Loose Brick** ☐ Deteriorated
Infiltration: ☐ None ☐ Joint ☐ Cracks ☐ Mortar ☐ Roots ☒ **Wall**

Chimney

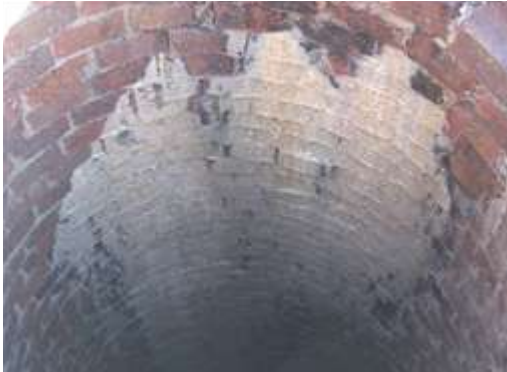
Defect 2

Corbel Material: **Brick** ☐ Parged Type: **Concentric/Eccentric**
Condition: ☒ Sound ☐ Cracked ☐ Root Intrusion ☐ Loose Brick ☐ Deteriorated
Infiltration: ☐ None ☐ Joint ☐ Cracks ☐ Mortar ☐ Roots ☒ **Wall**

Wall

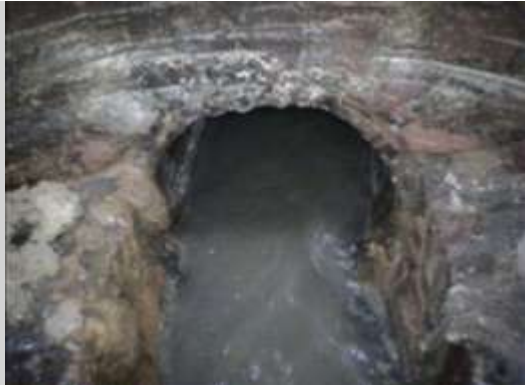
12 O'Clock Outflow

12 in. Circular Gravity Sewer
Pipe Out @ 12 O'Clock

Pipe Height: **14.4** (in.) Rod and Bar (Angled)
Pipe Material: **Clay** ☐ Pipe Lined
Invert Depth: **14.51** (ft.) Flow Characteristics: **Fast**
Deposits: ☒ None ☐ Mud ☐ Sludge ☐ Debris ☐ Grease
Silt Depth: (in.) Deposits Extent:
Infiltration: **None** Pipe Seal Cond: **Sound**

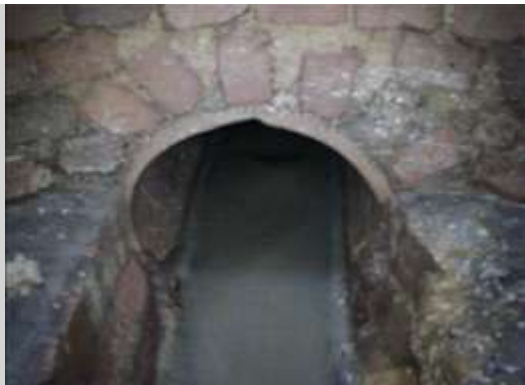
6 O'Clock Inflow

12 in. Circular Gravity Sewer
Pipe In @ 6 O'Clock

Pipe Height: **13.2** (in.) Rod and Bar (Angled)
Pipe Material: **Clay** ☐ Pipe Lined
Invert Depth: **14.41** (ft.) Flow Characteristics: **Fast**
Deposits: ☒ None ☐ Mud ☐ Sludge ☐ Debris ☐ Grease
Silt Depth: (in.) Deposits Extent:
Infiltration: **None** Pipe Seal Cond: **Sound**
